# Petrolheads: Managing England's Early Submarines

Mark Dunkley  
Hanna Steyne

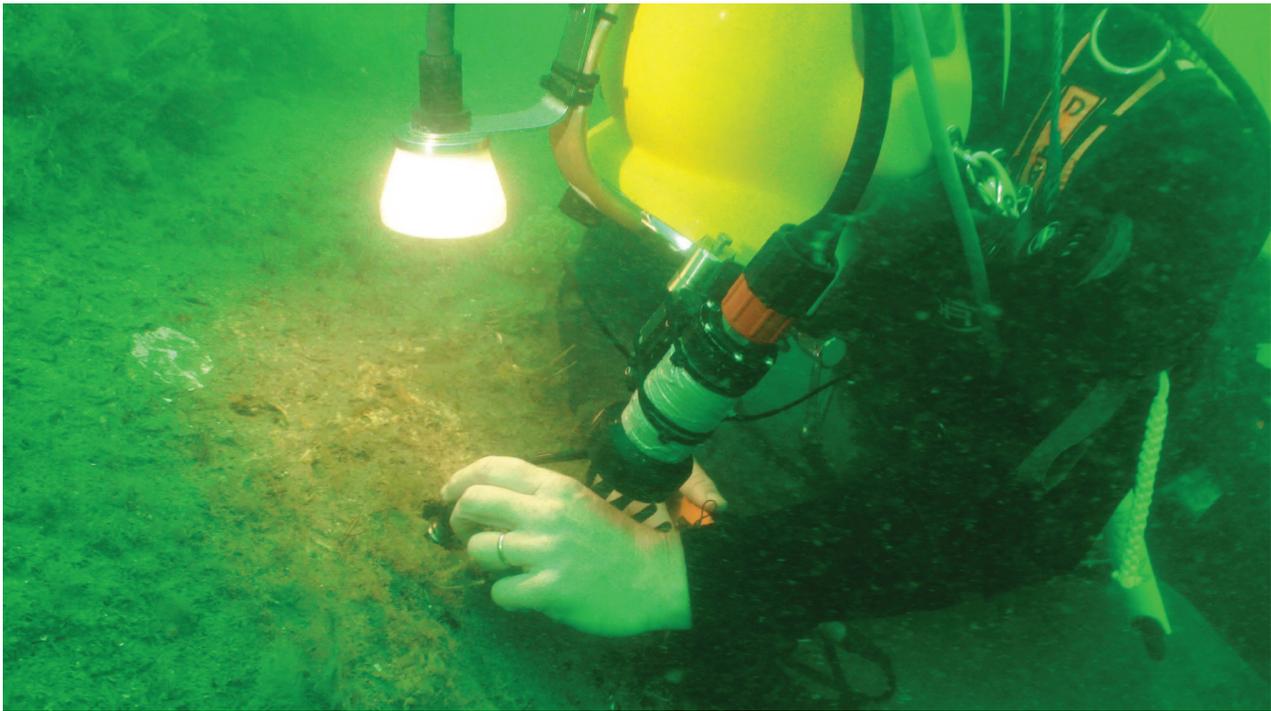
FIGURE 2. USING THE CYGNUS DIVE UTG TO MEASURE THE HULL OF THE A1 SUBMARINE (CROWN COPYRIGHT).

thick was removed. The probe of the Cygnus gauge was then held against the exposed steel hull to measure its thickness (and repeated a number of times to confirm the reading) (Figures 2 and 3) and the cavity was made-good with epoxy putty.

Investigation on the *Holland No. 5* was purposely limited to a single reading of 6.5 mm, while readings on the *AI* of 5.6 mm, 5.7 mm and 8.4 mm (against a known 'as built' thickness of 11.1 mm) demonstrate potential variability of hull thickness. These measurements show the need for numerous readings to be taken across a hull to identify erroneous readings and thickness variability in order to locate areas of instability.

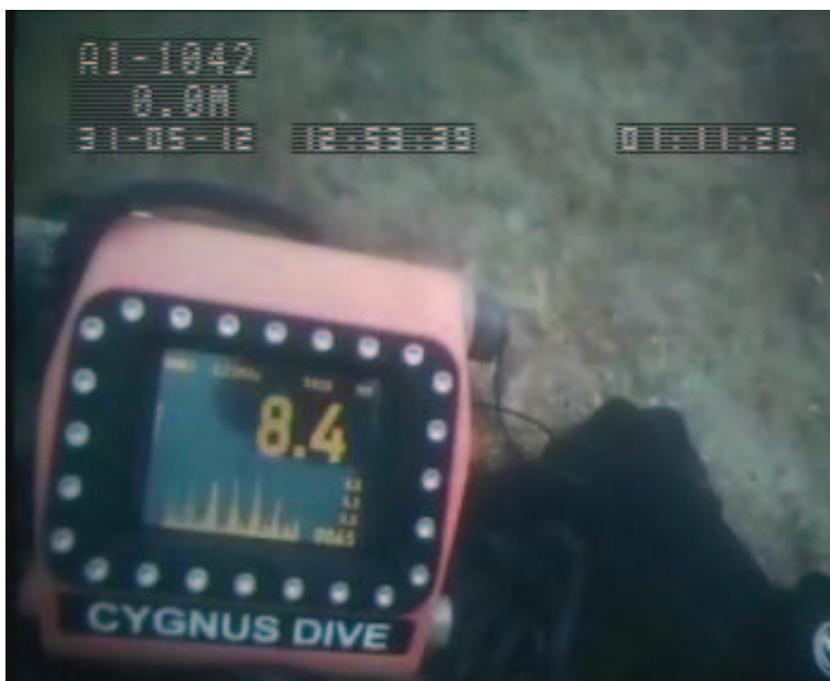
FIGURE 3. THE CYGNUS DIVE UTG DISPLAY, SHOWING (CLOCKWISE FROM TOP RIGHT) THICKNESS READING (8.5 MM), PREVIOUS LOGGED MEASUREMENTS, ECHO-VERIFICATION BARS AND BATTERY LEVEL (CROWN COPYRIGHT).
