# **Pollution in Plymouth Sound and the Tamar Waterway**

## **A Historical Review**

**Peter Holt**

**The SHIPS Project CIC 2023**

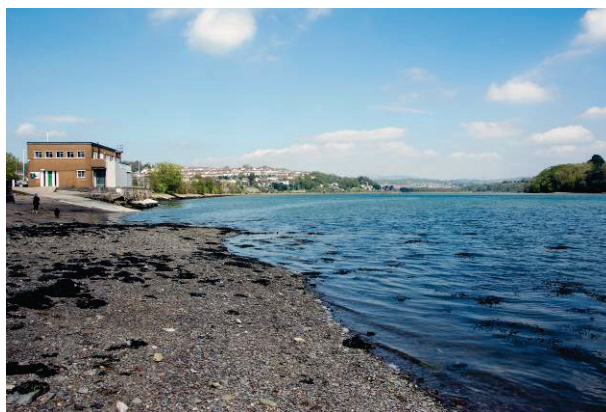
**Figure 3: The embankment on the west side of the Laira, a man-made landscape [The SHIPS Project]**

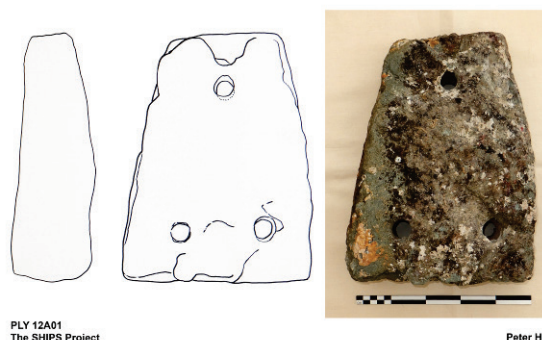
**Figure 5: One of the Mediterranean Bronze Age style stone anchors found in Plymouth Sound [The SHIPS Project]**

Stone tools found on the shores of Plymouth Sound show that the earliest visitors to the area had a connection with the sea. Human remains found in caves in Cattedown have been dated to 12,000 BCE and later stone tools have been dated to the Mesolithic and Neolithic suggesting that the area had been occupied continuously for millennia (Firth et al, 1998). The next visitors who left traces were traders in the minerals tin (Sn) and copper (Cu) used to make the alloy bronze, coming to the Mount Batten peninsula by sea in the Bronze Age (Cunliffe, 1988). The lower reaches of the Plym river known as the Cattewater is a natural harbour, well set back in Plymouth Sound and protected from strong winds, it provides a secure anchorage next to a firm shelving foreshore which is ideal for haul boats up on, with dry and level ground behind the beach for a settlement. It is hard to say how early Mount Batten was first used by people, but the first signs of intensive occupation begin in the 8<sup>th</sup> century BC, with Armorican bronze axe heads found at the site indicating trade with Brittany in northern France. It has been suggested that this trade was with ships coming west along the coast from Portland in Dorset, connecting with larger vessels that would cross the English Channel to France. However, evidence of ships using Mediterranean Bronze Age technology can be found in the many ancient stone anchors found in Plymouth Sound, anchors whose parallels can be found in abundance in the Mediterranean (Fig. 5). Perhaps the technology used by these foreign ships was adopted by local craft or ships coming from the Mediterranean may have visited Plymouth. What we can say is that the presence of so many stone anchors is evidence of a very early connection between the Mediterranean and southwest England.

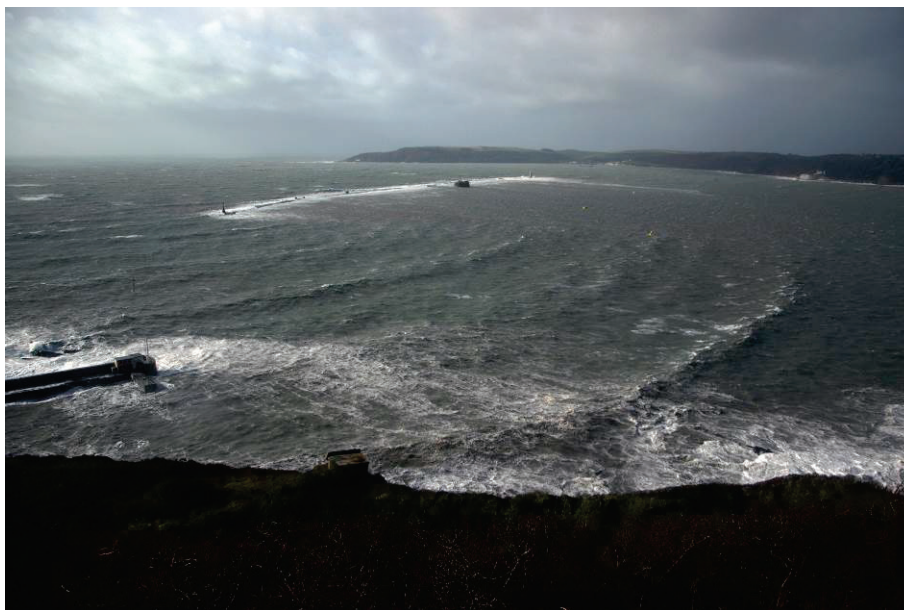
**Figure 7: The Breakwater sheltering the waters of Plymouth Sound in a storm. Huge waves still make their way in through the eastern entrance showing what storm conditions would have been like in Plymouth Sound before the Breakwater was built. [The SHIPS Project]**

Losses from shipwrecks became such a problem in the 19<sup>th</sup> Century that a huge Breakwater 1560m long was constructed across the entrance to Plymouth Sound to protect shipping in the harbour (Fig. 7). The construction of the Breakwater changed the flow of water in Plymouth Sound, with the massive construction forming an obstacle to both tidal flow and to the outfall from the Tamar and Plym rivers. Comparisons between charts dated before and after construction show that the area north of the Breakwater is now shallower, with Jennycliff Bay accreting approximately 5m of sediment since 1798 (Heather, 1798). It is hard to determine what effects the additional deposition of sediment had on wildlife in the bay because the Breakwater was providing effective protection by 1814 and there are no records of the seabed environment from before that date. The marine ecosystem in the Sound has had more than 200 years to stabilise the habitats that were modified by the addition of the Breakwater so those habitats are what can be considered 'natural' today. In 1881, a smaller breakwater was built at Mount Batten to provide further protection for ships at anchor in the Cattewater and this also had the effect of helping trap sediment in its lower reaches. By 1948, the Cattewater had silted up yet again to such an extent that it was affecting shipping trade and dredging was urgently required (WMN, 1848) The shoaling of the Cattewater by tin mining runoff, ballast

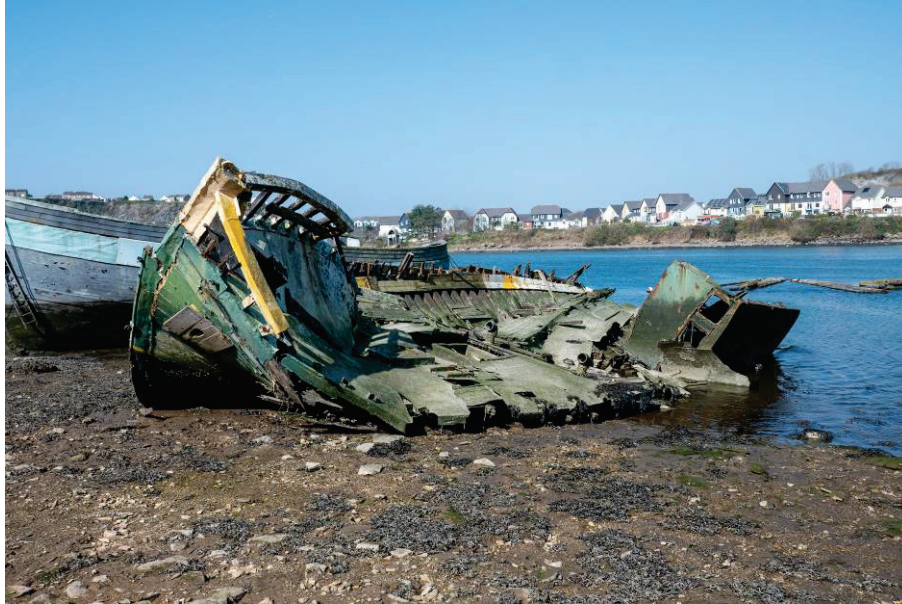
**Figure 9: A hulk called *Destiny*, or perhaps *Mam Goz*, falling apart in Hooe Lake in 2022. Timbers and fibreglass from this ship are scattered across the foreshore [The SHIPS Project]**

The older, timber-built hulked vessels may be less of a pollution hazard as they pre-date most unpleasant contaminants and any that were present on the vessel are likely to have been washed away by the action of the sea and rain. More modern shipbreaking sites and abandoned hulks are a different story. The low-lying 'hump' that can be seen in the mud by the stone jetty in Hooe Lake is the remains of several 1960s-era vessels broken up there. The visible remains include corroded steel, tyres, plastic, oil, and asbestos matting while it is likely that the sediment contains antifouling paint residue and oil-based lubricants. Many abandoned wooden fishing vessels dating from the 1960s lie on the foreshore in the waterway. Tanks inside the hulls may still

contain diesel fuel and machinery may still contain lubricants so these ships may become a source of pollution as they collapse. The timber or steel hull may be unsightly but not poisonous, but these ships were once painted with TBT antifoul paint below the waterline which in many cases has now partly washed off. Paint containing tributyltin (TBT) was found to be an effective antifouling coating for ship hulls, becoming popular in the late 1960s but a few years later the undesirable consequences of pollution from the paint became apparent. TBT has toxic effects on a range of marine organisms, it particularly affects gastropod molluscs and was found to destroy oyster beds. Paint containing TBT was prohibited from use in the UK from 1987 on all vessels smaller than 25m but continued to be used on larger vessels until banned on all ships in 2008 (Santillo, 2001). Unfortunately, TBT is readily incorporated in marine sediments which may act as reservoirs for the substance, releasing the compound back into the water for many years (Pope, 1998).

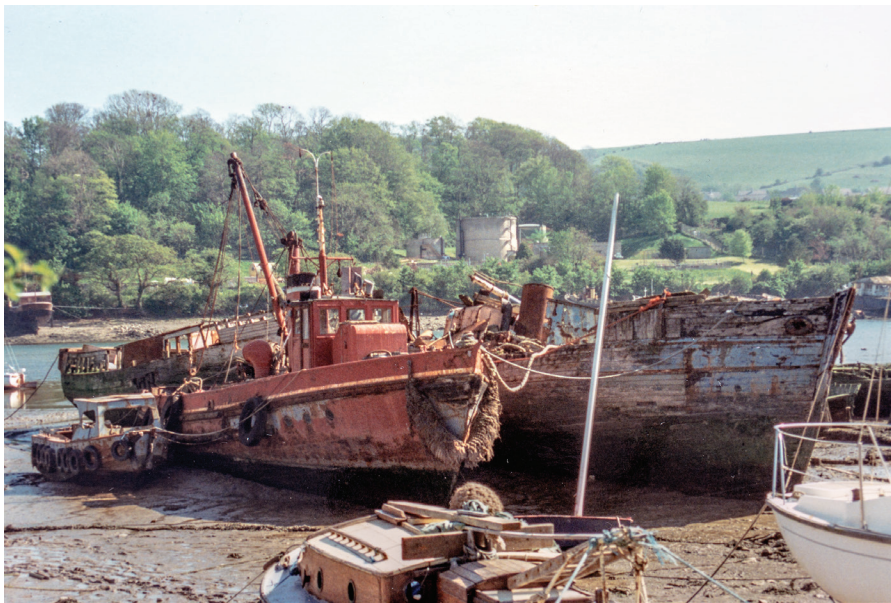
**Figure 10: Shipbreaking in Hooe Lake in the late 1980s, the pollution from this activity can still be found in the seabed. [Jack Baker]**

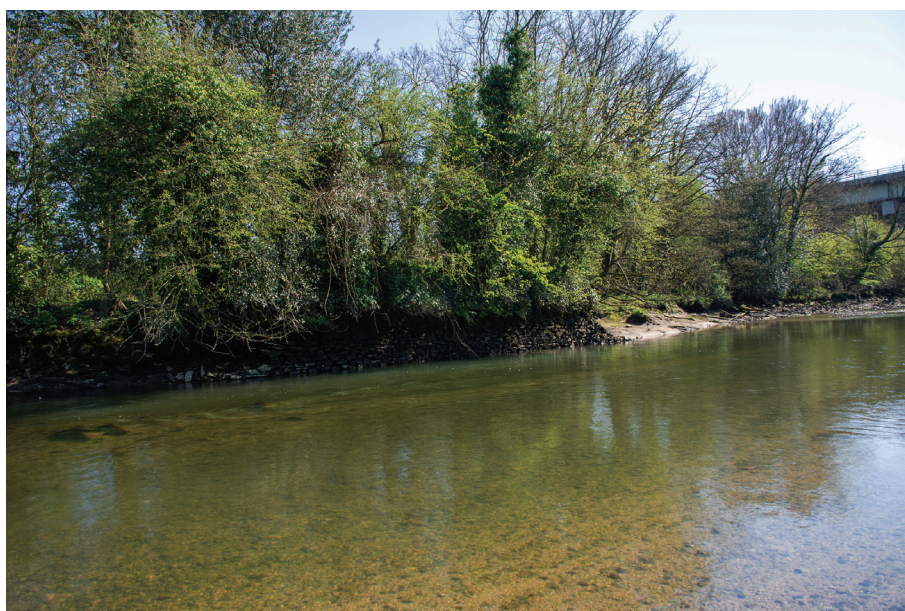
**Figure 12: Small stone-built quays can be found all along the waterway; this one is at Longbridge on the River Plym [The SHIPS Project]**

The sheltered valley of the Tamar river was found to be an ideal location for growing crops. Produce was initially sold locally but improvements in river transport made it possible to ship fruit and vegetables downriver to be sold at markets in Plymouth. For this to happen, small quays were built all along the banks of the waterway where farmer's wagons could load straight into waiting boats. Many of the small quays can still be seen today in various states of disrepair along the banks of the rivers Tamar, Lynher and Tavy.

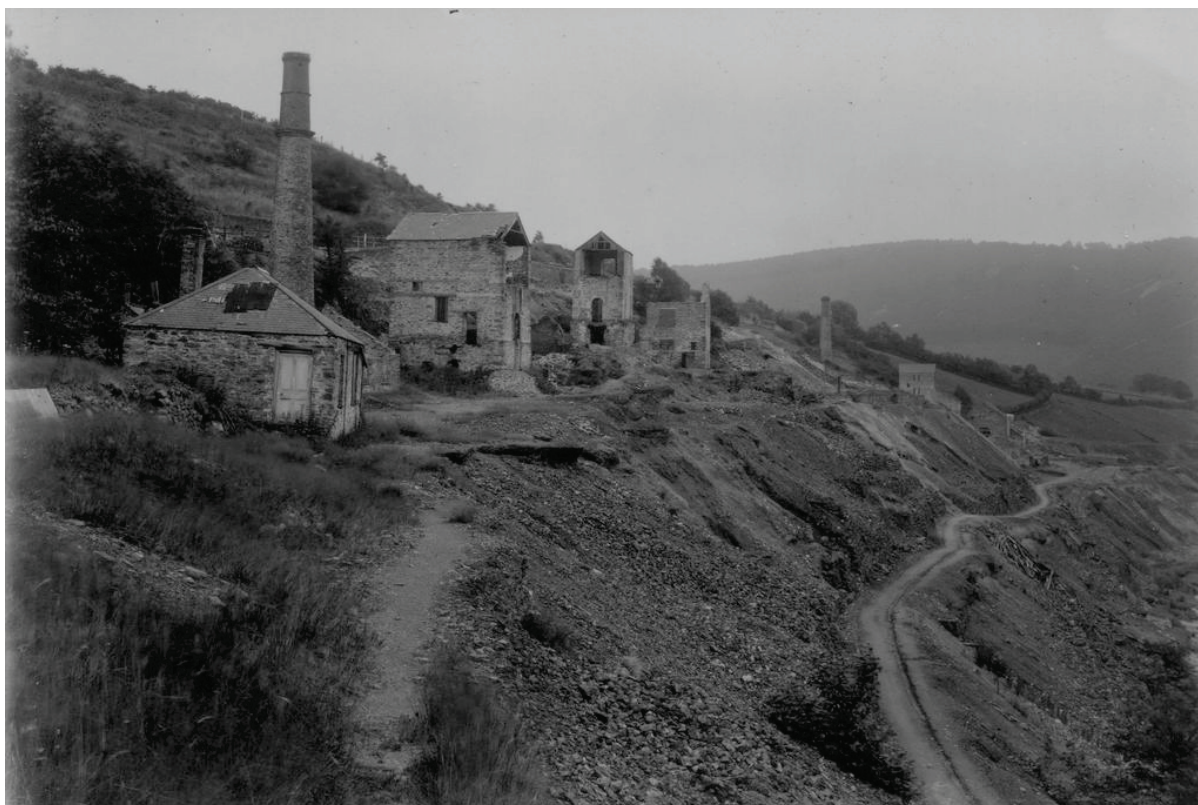
**Figure 13: A disused Okel Tor Mine on the banks of the Tamar at Calstock, showing the devastation to the landscape that can be created by mineral extraction [The SHIPS Project]**

Mineral extraction on land within the Tamar waterway catchment has had a significant and long-lasting effect on the waterway. Mining and mineral processing on an industrial scale also changed the shape of the landscape while uncontrolled runoff from the mines and quarries choked rivers and polluted their sediments.

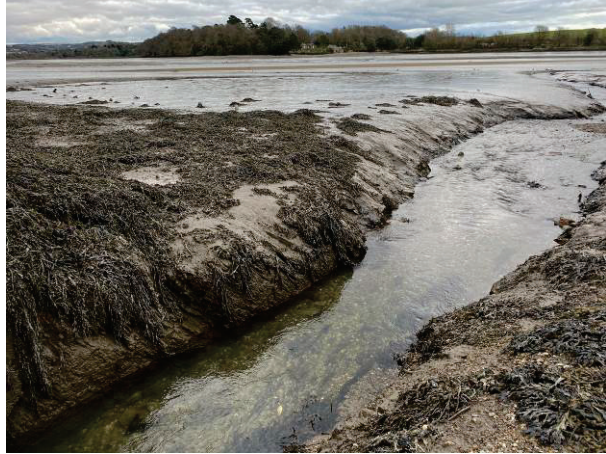
**Figure 14: A 1.5m thick layer of estuarine mud in the Laira is cut through by a stream to show the hard sand and gravel underneath [The SHIPS Project].**

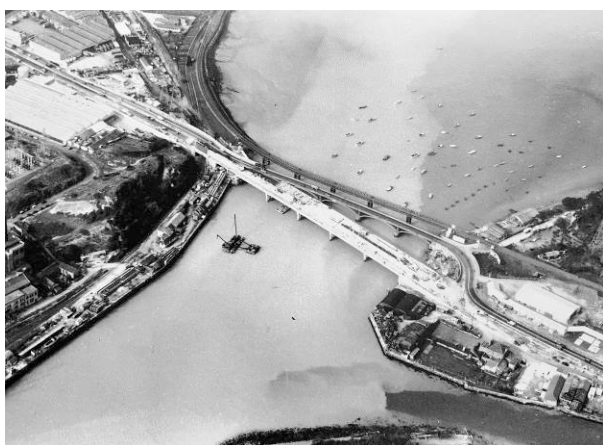
**Figure 15: White china clay runoff can be seen in the river Plym in this aerial view of Laira Bridge under construction in 1961 [Cyberheritage]**

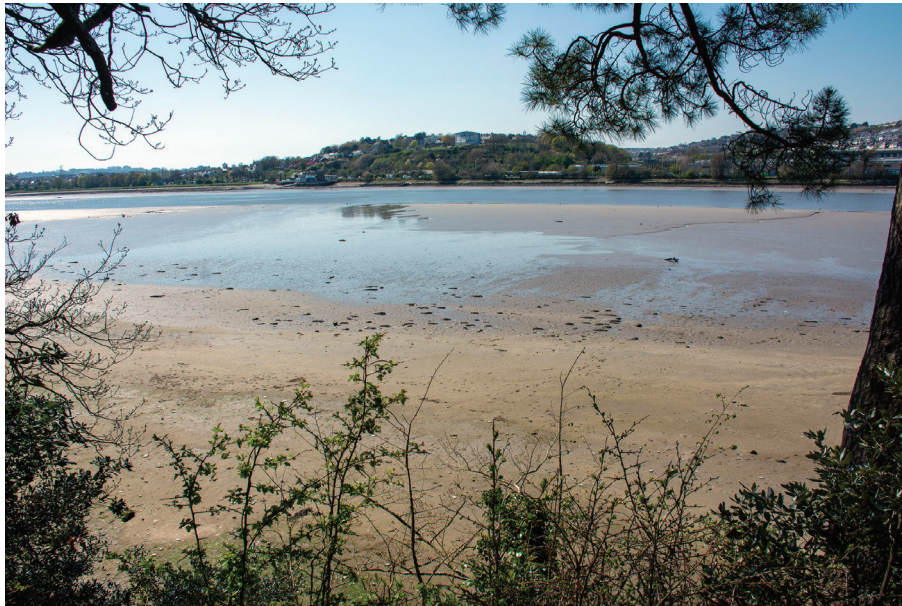
**Figure 16: The flat tracts of sand that now fill the Laira dry out at low tide [The SHIPS Project]**

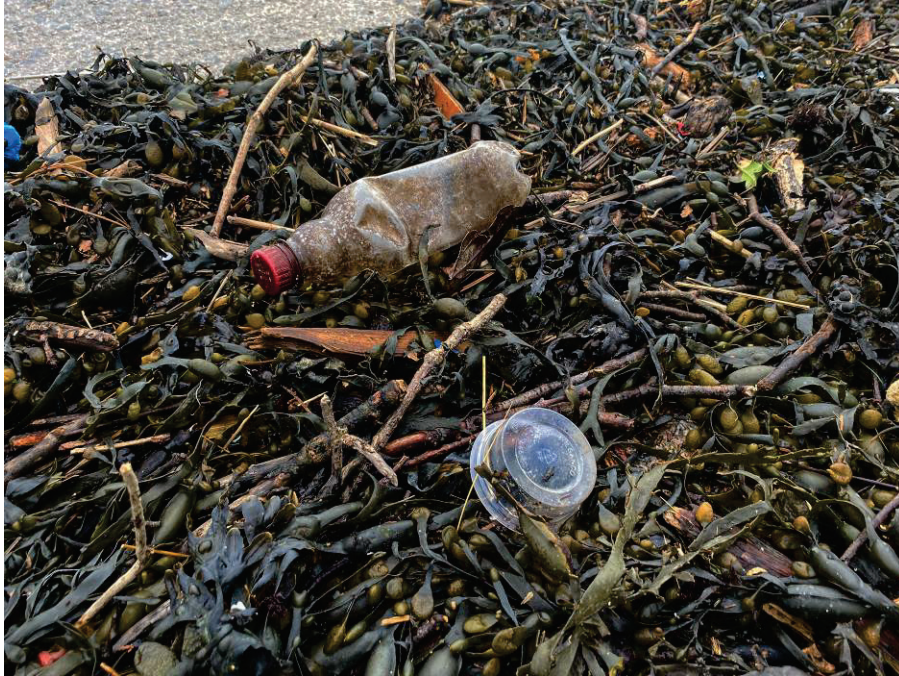
**Figure 18: A scourge of the modern age, single-use plastics washed up on the strandline [The SHIPS Project]**

Up until the Second World War, most domestic pollutants were short-lived in the environment, were low in volume or were inert and would have little impact on the ecosystem. By the 1940s this was to change dramatically with synthetic materials like nylon, acrylic, neoprene, SBR and polyethylene (PE) becoming widespread (Recyclenation, 2011). These new materials were the wonders of the age being cheap to produce, hard-wearing, light in weight, strong and food safe, so became used for everything from packaging to clothes to fishing nets. Unfortunately, these same materials do not break down safely in the environment and they shed fragments and microplastics that adversely affect marine life in ways that we are only starting to comprehend. In the 1950s, High Density Polyethylene (HDPE) was developed, and plastic bottles made from this new material quickly became popular, then in 1978 Coca-Cola and Pepsi introduced the first 2-litre polyethylene terephthalate (PET) plastic bottles to the world (Coca-Cola, undated). Plastic replaced the glass bottles that had been used since the Victorian era, bottles that could be returned and reused, and if they ended up being thrown away the glass they were made from was largely inert. But glass is heavy and expensive to transport, and it breaks easily forming dangerous fragments, so there was both commercial and consumer pressure to replace the glass with plastic. So now the sea surface, seabed and seashore are littered with millions of plastic bottles and other single-use plastic items.

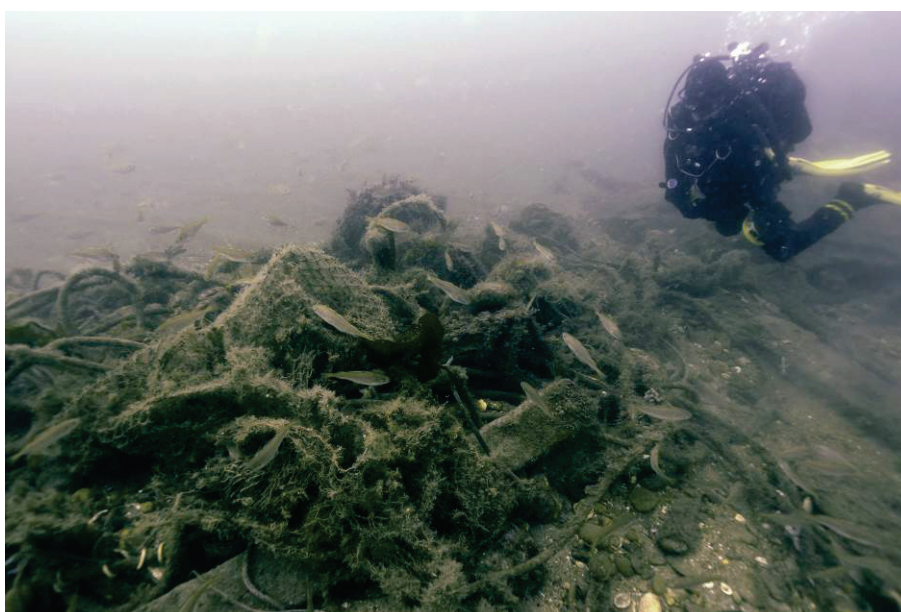
**Figure 20: Lost fishing gear on the wreck of the WWII armed trawler Kingston Alalite in Plymouth Sound. The nets still trap marine life and are a source of plastic pollution [The SHIPS Project]**

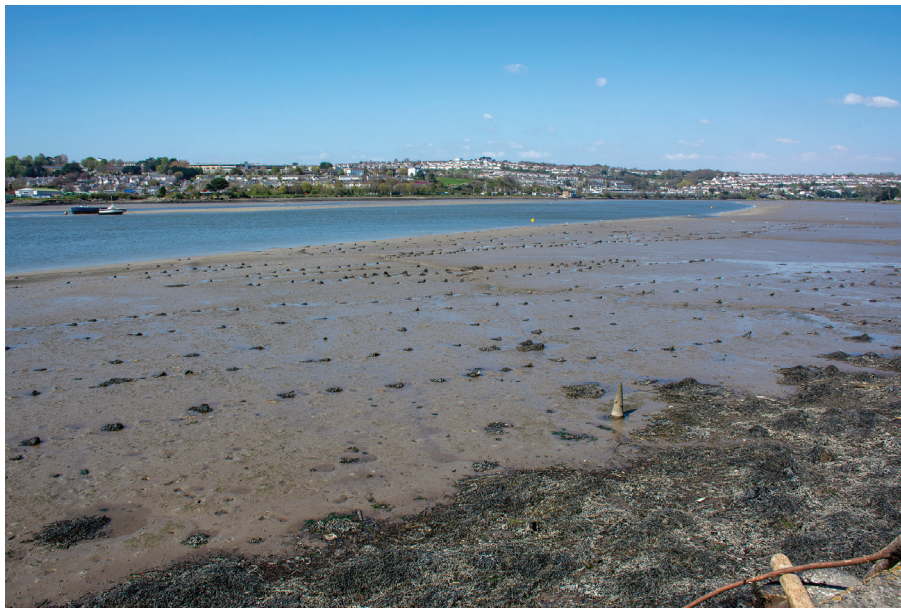
**Figure 23: Crab 'tiles' in the Laira, here plastic guttering has been pushed into the soft foreshore sediment [The SHIPS Project]**

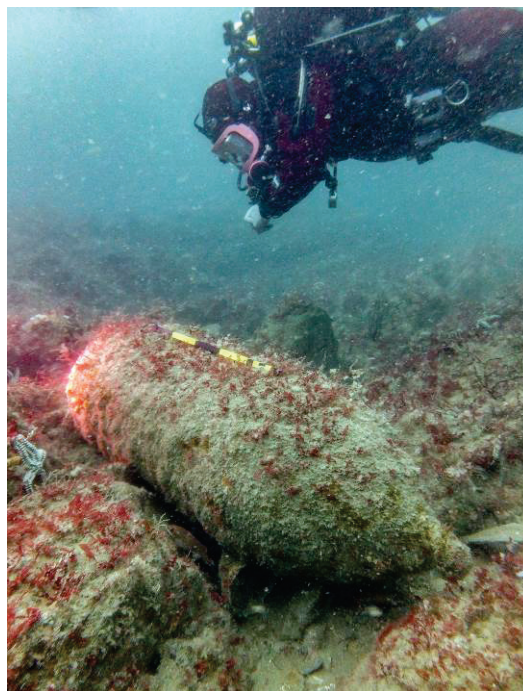
**Figure 24: Unidentified ordnance on the seabed in Plymouth Sound, the scale bar is 500mm long [The SHIPS Project]**

Ordnance of all kinds and ages can be found on the seabed and rivers around Plymouth Sound. Many armed wooden sailing vessels were wrecked in Plymouth Sound and round shot from their guns can often be found on the seabed. Along with the many solid iron round shot can be found the occasional, much older round shot made of stone which would have been fired from the earliest type of cannon. Some of the iron cannon that fired round shot can also be found on the seabed, these guns survive well underwater and can often be the last remaining evidence of some maritime catastrophe long ago, when the rest of the shipwreck has washed away. Many of the Palmerston forts built in the 1860s that surround the city face Plymouth Sound, so practice rounds fired from the large guns mounted in the forts ended up in the sea. Large numbers of shells of different types can be found on the seabed in places where the guns were routinely aimed when training their gun crews. The outside casing of the shells is made of cast iron which survives well in seawater, so the shells are often found intact by divers. WWII-era artillery rounds can also be found on the seabed, either lost on a shipwreck or simply dropped overboard. In 1940, the Germans dropped aerial mines at the entrance to Plymouth Sound using aircraft, a pair of mines would often be dropped, perhaps one triggered by acoustic waves and the other by magnetic disturbance, and they succeeded in sinking at least five vessels in this way in just six months. Vessels would be anchored outside of the Breakwater and tasked with watching for the fall of these mines to see where they landed in the sea so divers could be sent out later to dispose of them. Not all the mines were located so some can still be found on the seabed. Not all the bombs dropped on the City and in the Dockyard during the Plymouth Blitz fell onto dry land and some ended up in the sea, in the Cattewater and the Tamar. Not all the bombs that landed in the sea and rivers were recovered so these too can be found on the seabed. Other ordnance found in Plymouth Sound includes several WW1-era torpedoes from practice firing in Cawsand Bay and off Penlee Point, fortunately not dangerous as they were fitted with dummy warheads. There is a report of a sports diver seeing the remains of a wire-guided Brennan torpedo fired from Pier Cellars in Cawsand Bay and lost off the Breakwater, a rare example of the world's first guided weapon (Beanse, 1997). The correct procedure for dealing with unexploded ordnance is to report it to the Coastguard who will pass on the information to the relevant authorities.

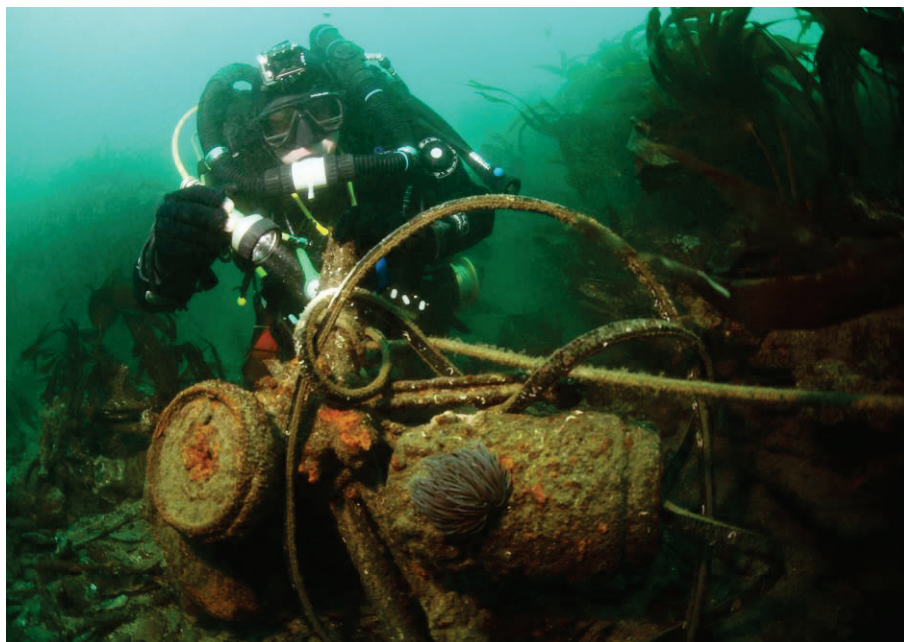
**Figure 25: A diver explores the remains of Short Sunderland Mk II flying boat W3998 that crashed south of Plymouth Breakwater on 21<sup>st</sup> December 1941 with the loss of 11 lives [Neil Hope]**

There are records of 18 aircraft that crashed in Plymouth Sound, most were constructed from aluminium but with some steel components. The aluminium airframes break up into small pieces that can be found scattered across the seabed in several locations in the Sound. The steel components such as engines and landing gear remain at a few of the crash sites although most have nothing left to mark their location as many of the engines were recovered in the 1970s and 80s. These crash sites are also memorials because more than 80 Allied and German airmen died in the air crashes and 43 airmen were never recovered from the sea (Holt & Haas, 2022a). All the aircraft crash sites are protected under the Protection of Military Remains Act 1896 making it an offence to interfere, without authority, with the wreckage of crashed, sunken and stranded military aircraft and vessels, and with associated human remains.

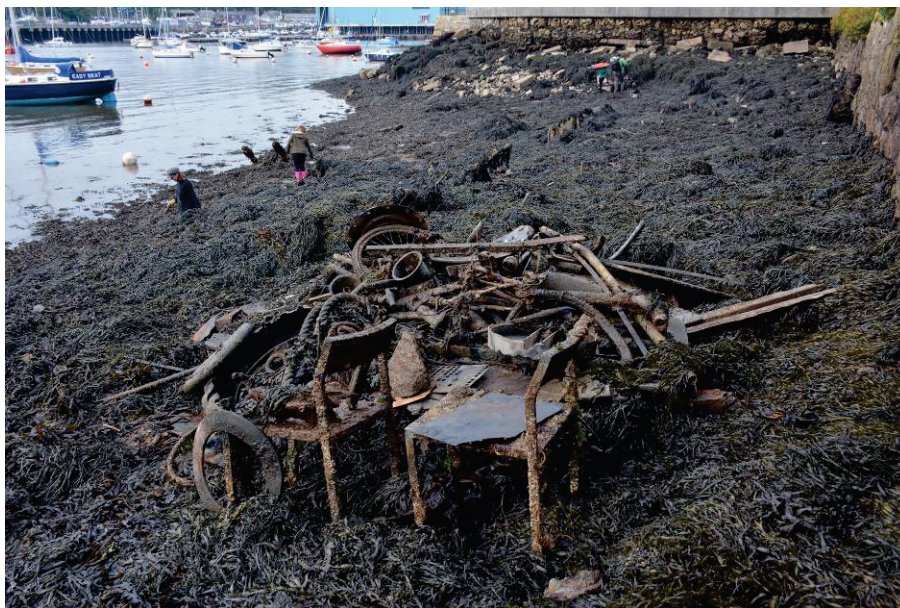
**Figure 28: Metal and plastic junk removed from the foreshore at Stonehouse during a 1000 Tyres Project clean-up operation [The SHIPS Project]**

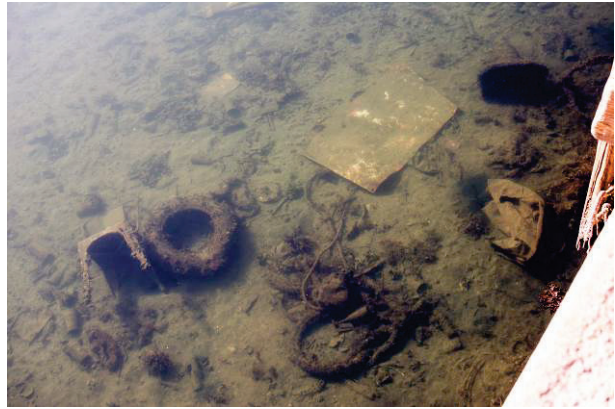
**Figure 29: A tyre, plastic chair, plastic bags, drinking glasses, and unidentified debris on the bottom in Sutton Harbour [The SHIPS Project]**

Modern litter found all along the edges of Plymouth includes plastic road cones, car and truck tyres, shopping trolleys, bicycles, motorbikes, scaffolding poles, and unidentified scrap metal, along with plastic of all types and sizes. One of the more common items to be found on the bottom of Sutton Harbour is the heavy PVC plastic ‘feet’ from temporary fencing, along with the usual large quantity of tyres and road cones. Many lighter items get blown into the water such as plastic bags and plastic wrapping, and on one clean-up the 100 Tyres team recovered several large plastic roadside banners made by organisations to publicise events. Waterside pubs are rich hunting grounds for waste material such as plastic chairs and sunshades, often laid on top of a thick stratum of bottles and drinking glasses.

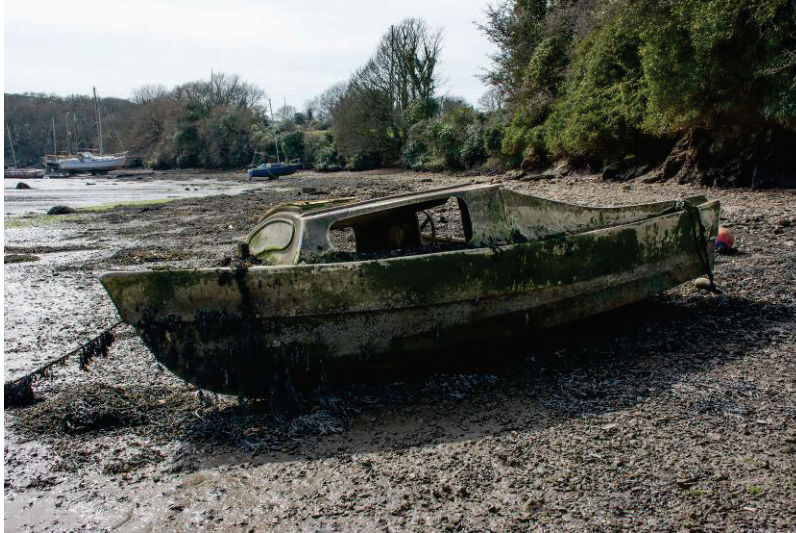
**Figure 30: Abandoned plastic boats can be found all over the Tamar waterway, they are difficult to recover and difficult to dispose of [The SHIPS Project]**

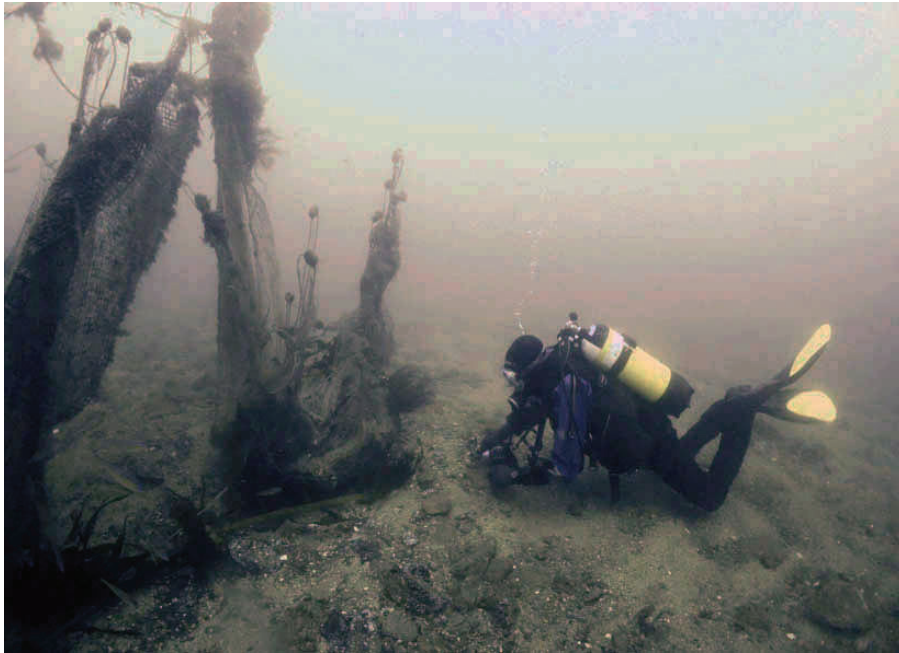
*Figure 31: Lost fishing gear snagged on the seabed off panther Shoal, south of Plymouth Breakwater. These nets are a hazard to both marine life and sports divers [The SHIPS Project]*

Plymouth started as a fishing port so lost fishing gear has always been a problem on the seabed and foreshore. Before the use of plastics for fishing gear, any lost gear would break down over time and wash away, but modern fishing gear only breaks down slowly and causes harm to the ecosystem for decades. Lost fishing nets continue to trap fish and other wildlife, with the dead marine life attracting the living so they too get trapped, but they also damage the seabed or cultural heritage they get snagged on. Floating fishing gear can foul ships'

propellers and steering gear while gear washed in from abroad can transfer invasive species. The plastic slowly breaks down scattering larger fragments across the seabed which degrade down to smaller fragments and then down to microplastics. Some of this plastic debris ends up on beaches and adversely affects recreation and tourism. Locating and removing lost fishing gear should be considered a priority.

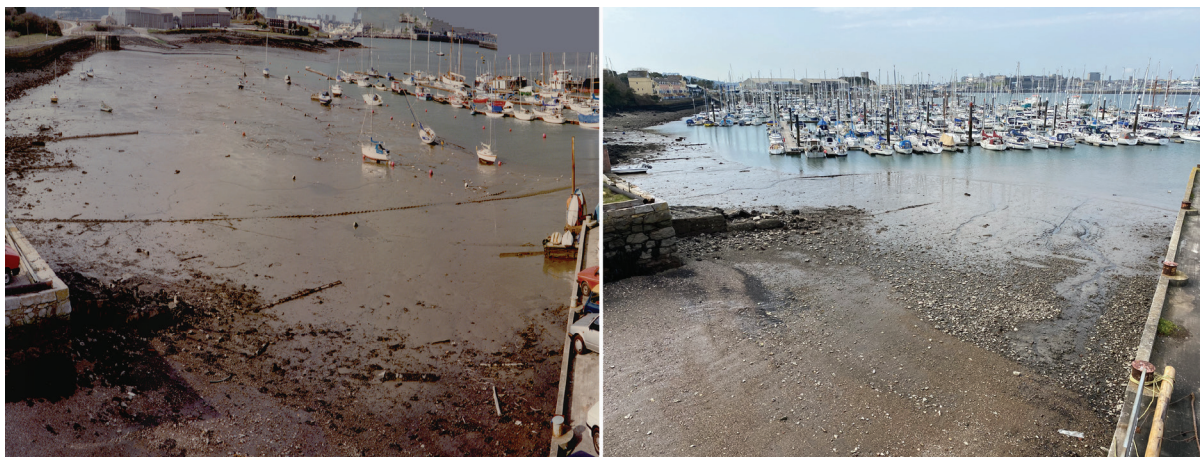
**Figure 32: Turnchapel beach pre-1995 (left) and in 2022 (right) showing that some of the mud has now gone from the beach, the residents recently removed tons of rubbish so now the foreshore habitat is much improved [The SHIPS Project]**

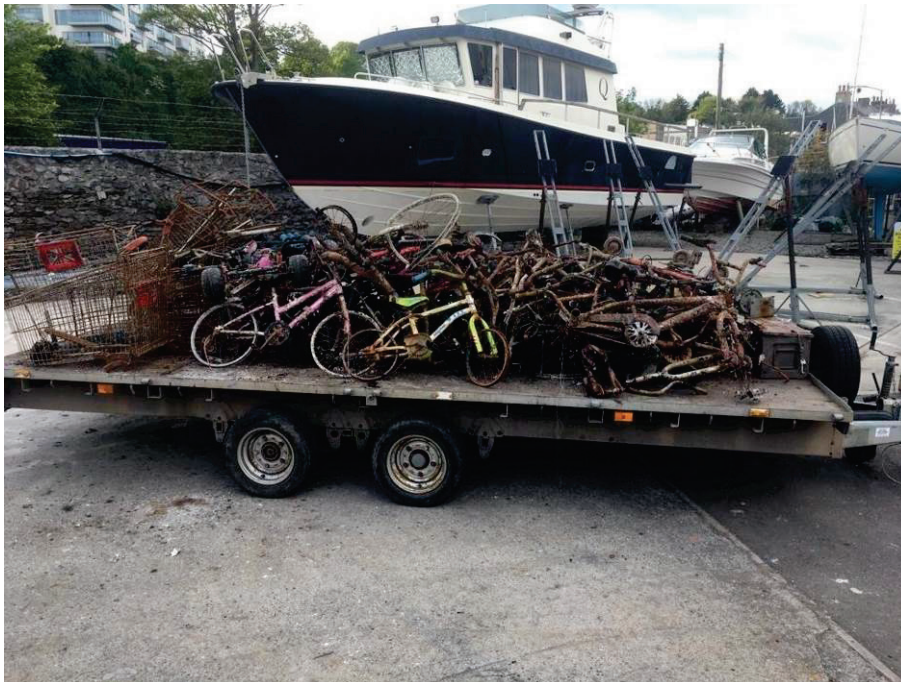
**Figure 36: Bicycles and shopping trolleys recovered from the seabed off Mutton Cove on one weekend in 2022 during a 1000 Tyres clean up operation [The SHIPS Project]**

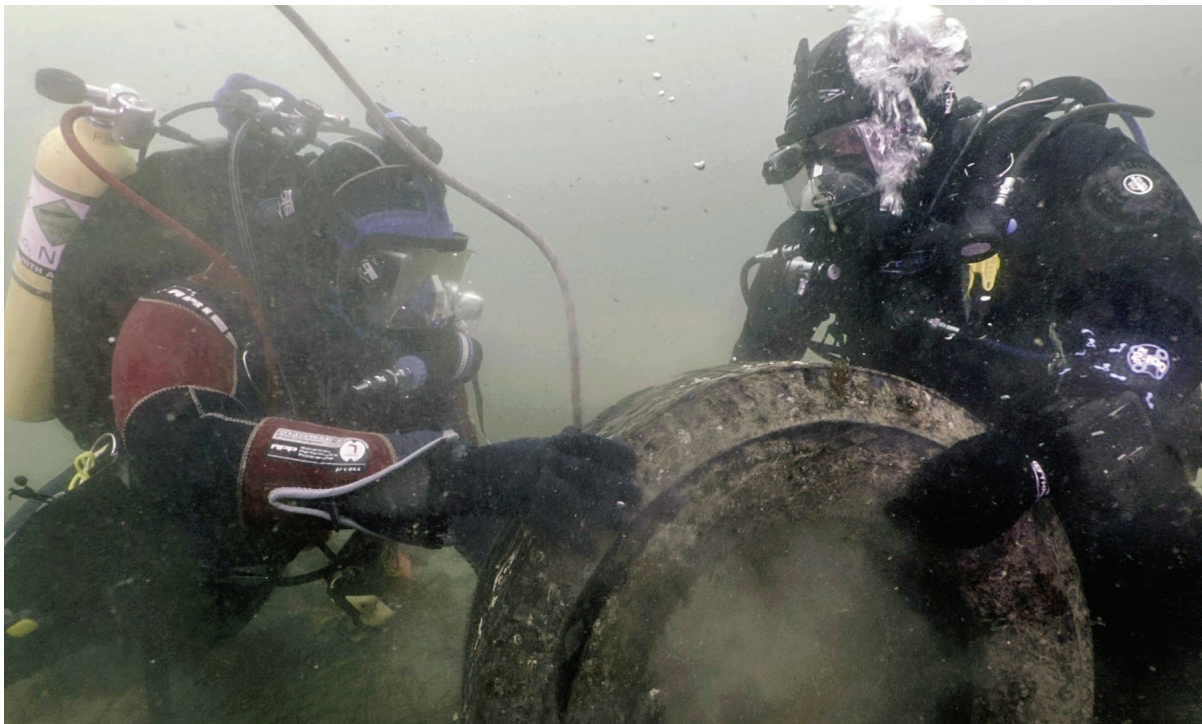
**Figure 37: 1000 Tyres Project divers recovering tyres from the bottom of Plymouth Sound [The SHIPS Project]**

Abandoned car and truck tyres are a particular feature of the seabed and rivers around Plymouth, with estimates of more than 1000 in Plymouth Sound alone. Tyres are a significant source of long-term pollution so are being removed from the foreshore and seabed of the Tamar waterway by the 1000 Tyres Project. Cars have occasionally been dumped in the sea with the remains of some still to be found on the beach at Bovisand Bay and Jennycliff Bay, with reports of more having been dumped off the end of Mount Batten Pier. These too are candidates for removal from the sea.
